June 2014

CATCHER IN THE WRONG: THE GENESIS CANISTER LIFT INCIDENT

Genesis Canister lift incident

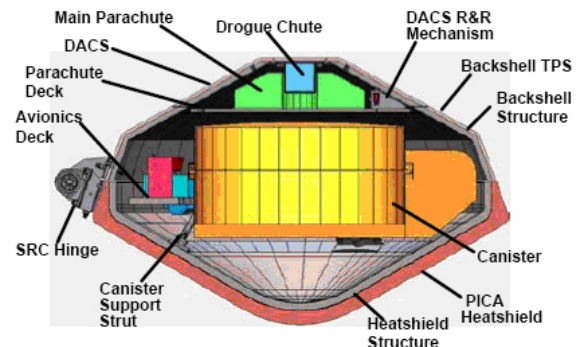
Genesis Sample Return Capsule (SRC)

The Genesis staff failed to observe that the fixture was coming apart at the tension bolts.

Just prior to mounting on the test chamber door, one corner of the Canister fell approximately 5 centimeters (2 inches) back onto the dolly. Nearby personnel cushioned the fall to achieve a soft landing on the dolly, and there was no damage to the canister or support equipment, or serious injury to personnel. (One of the test personnel had his finger caught between the bottom of the Canister and the transportation dolly. While he perceived the pinch to his finger, he was not injured. Some minor scratches were evident on the bottom where the Canister contacted the dolly, but no gouges were seen. The loose shackle swung and contacted one of the stiffening ribs on the Canister cover, leaving a very small ding on its corner.)

Post-incident inspection revealed that the threaded fastener had backed out of the Mechanical Ground Support Equipment (MGSE) fixture and became detached. The bolt that released had backed out at least a quarter of an inch, and this would have been easily observable. A second bolt was also backed out, but not as far. Additionally, the fasteners at the other tension fittings, and at the upper hoist point, were found to be only hand-tight.

5. What measures might have prevented the use of MGSE with un-torqued fasteners? [The fabrication or test organization could have thoroughly inspected all MGSE for fastener engagement and specified torque prior to delivery for use by a project. Where feasible, threaded components that are to be placed under tension could be designed with a positive locking device, or fastener heads could be spot bonded. Or the hoist ring could be replaced with longer bolts. While not every MGSE bolt needs to be torqued before a lift, all critical load path elements should be visually checked for thread engagements and torqued where necessary in accordance with the procedure (IBAT)]
